قناطر نجع حمادى الجديد

مشكلة البيزوميتير B10

GROUTING OF OPEN BOREHOLE IN THE CONSTRUCTION PIT AREA

Prepared by :Eng .Salah awad
3 November 2004

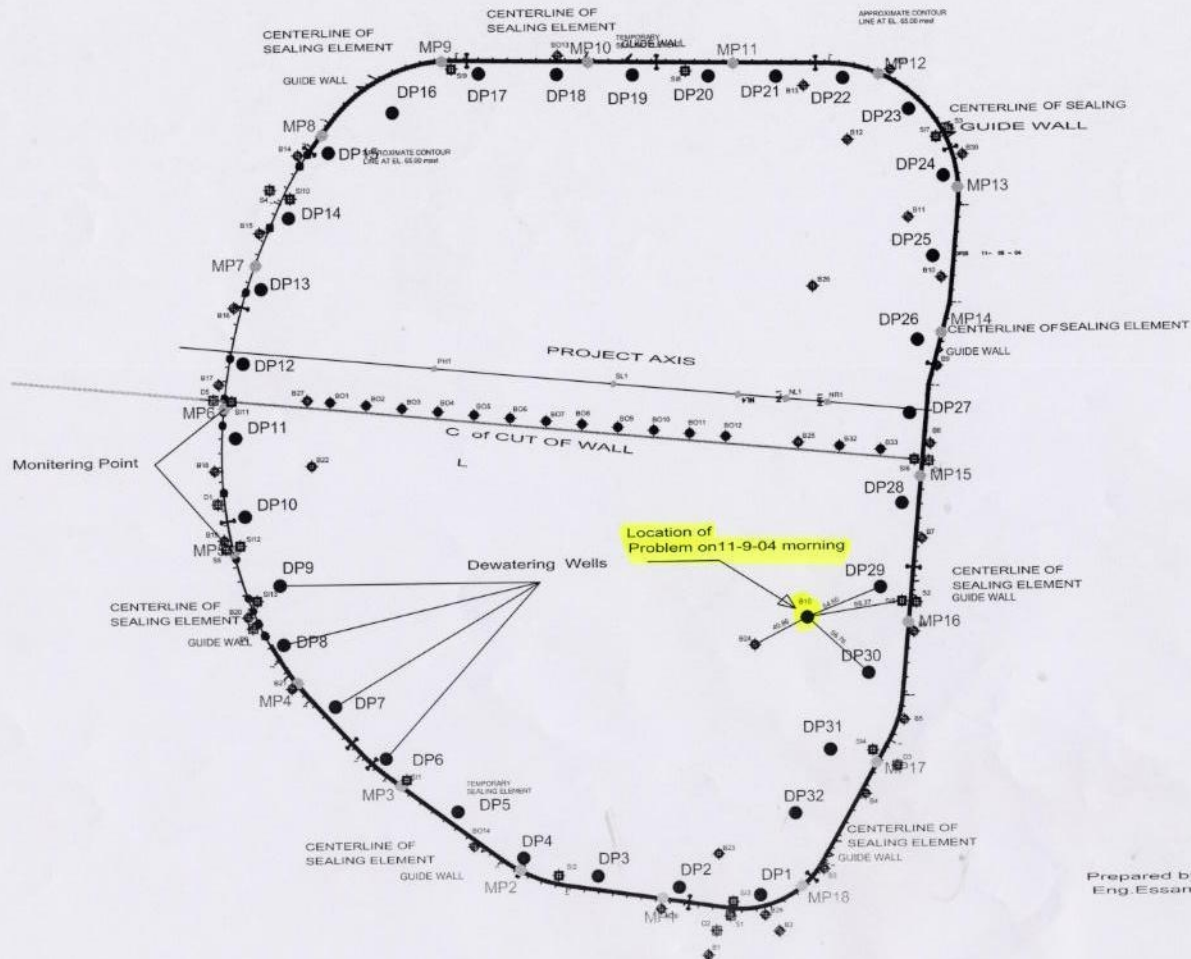
Fig 1

The first step is to find the old borehole from an upper level and hit it by drilling where it was observed at about (53.00)m asl .Therefore the hole must be opened again and a pipe with a diameter of 150 mm and a length of 9.00m high will be installed and raised to the drilling /grouting platform at(63.00)m asl .

1-Re-drilling and grouting (B10)

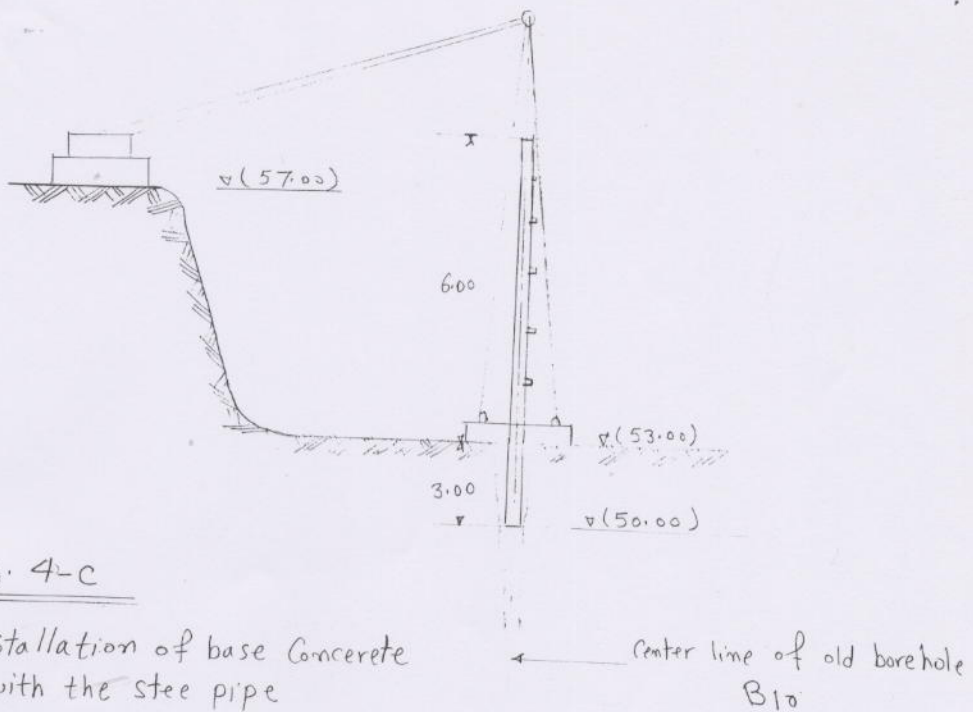
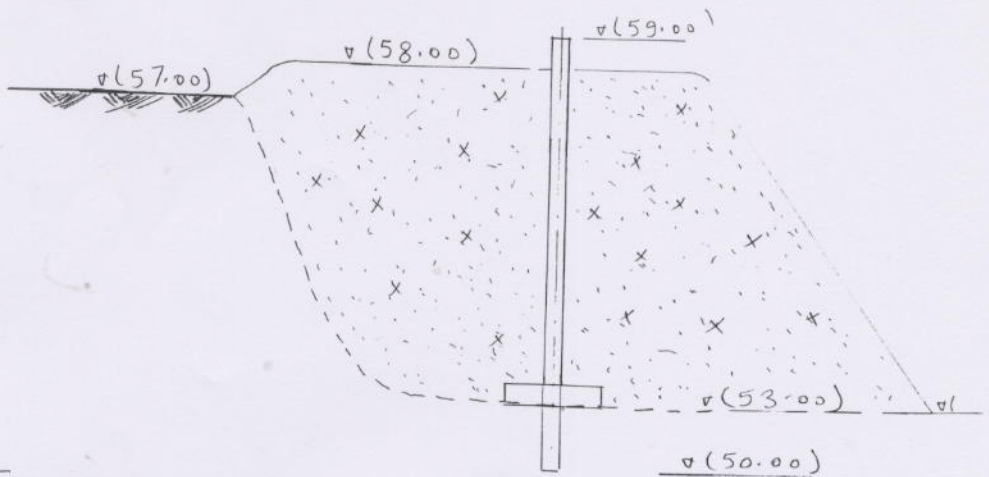
Fig 4-B

Back filling with Sandy Gravel Soil to stop water Leakage.

And then backfilling with sandy gravel soil to stop water leakage immediately after the spring occurred . After that access road was performed and platform was executed to place steel pipe 6 inch diameter at level (53.00)
